Test Report for
Crash Test according to ISO 7176-19
Wheeled mobility devices for use in motor vehicles

Test object: Minicrosser Model
 Manufacturer: Minicrosser A/S, Enggårdsvej 7, DK-7400 Herning

Test Report no: 21082008

Test object: Minicrosser Model

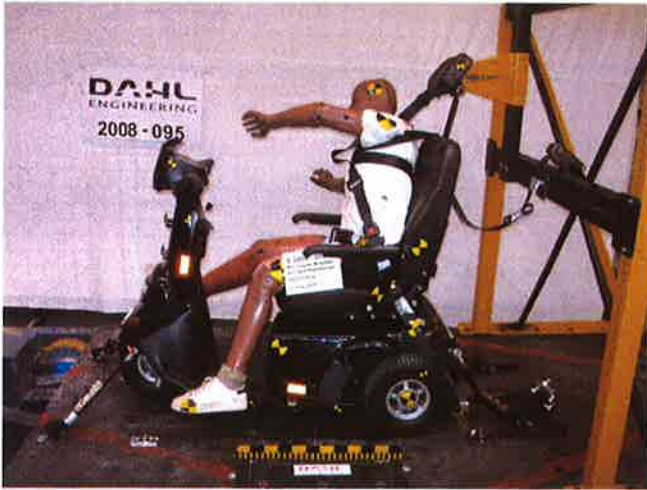
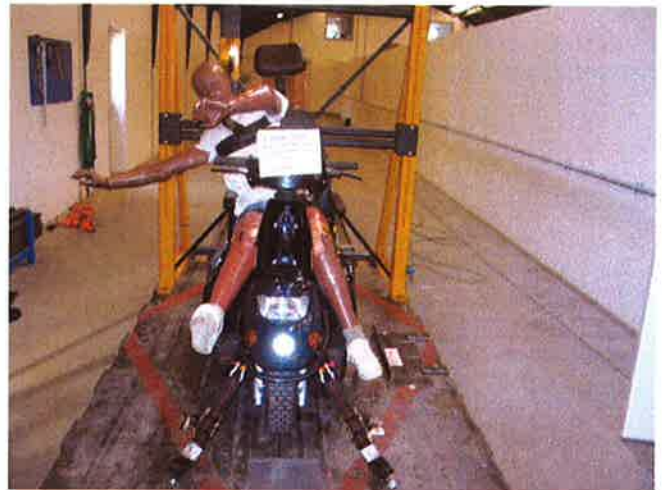
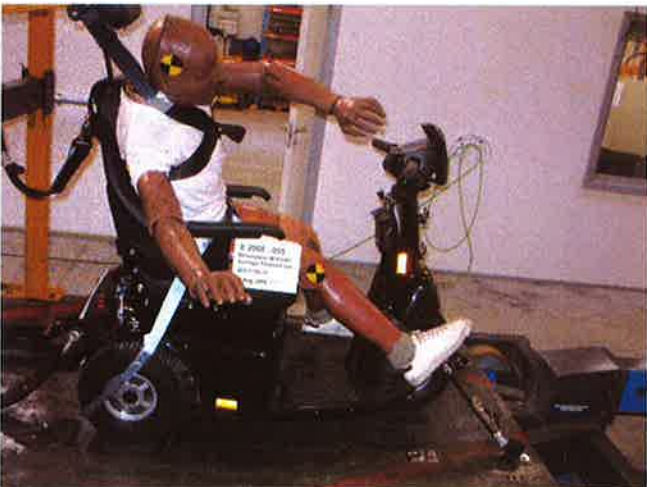
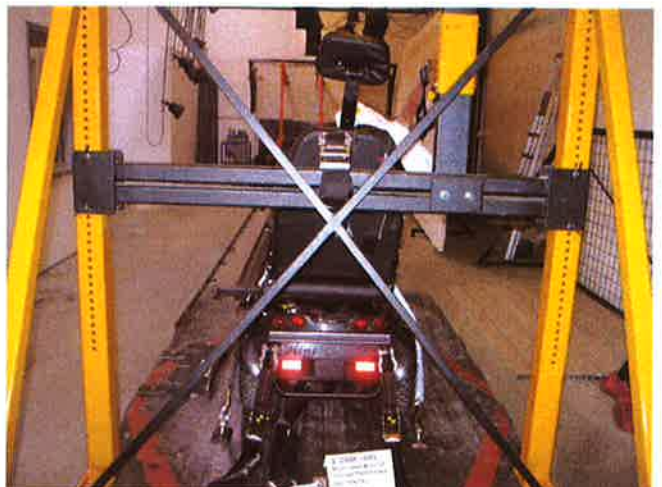
Post test photo's

5.2.2	After the test	
(a)	The wheelchair remained in an upright position on the platform	X
	The ADT remained in the wheelchair with its torso at an angle of not more than 45° to the vertical, when viewed from any direction	X

(b)	There were no visible signs of material failure on the wheelchair securing points	X
(c)	There were no components, fragments or accessories of the wheelchair with a mass of more than 100g that completely separated from the wheelchair	X

(d)	There were no fragmented or separated component, that may contact the occupant, produced with sharp edges less than radius 2 mm	X
(e)	There were no visible signs of failure on the wheelchairs primary load carrying components	X
