Periodical preventative
maintenance and inspection

Flexo Shower-toiletchair

51005199

MAIN 5199-2024-01

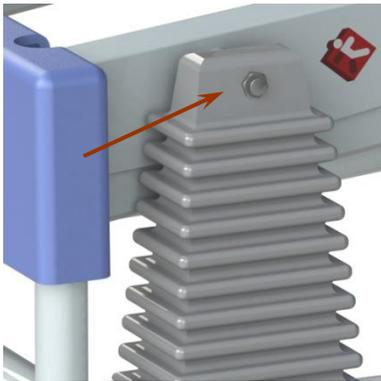
Figure 1 Bellow

1. Put the chair in a high position. Pull the bellows from the lever pin and slide them around the pump shaft. (See figure 1 Bellow)

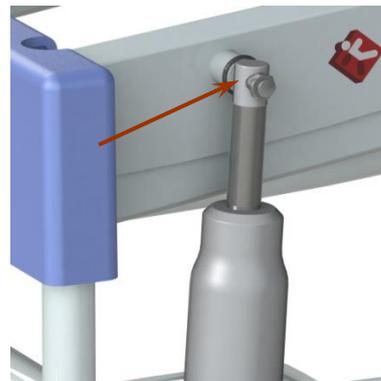
Figure 2 Pump

2. Detach the screw part. Pull the pump from the lever pin. **PLEASE NOTE: the upper frame is now loose and can go down!**

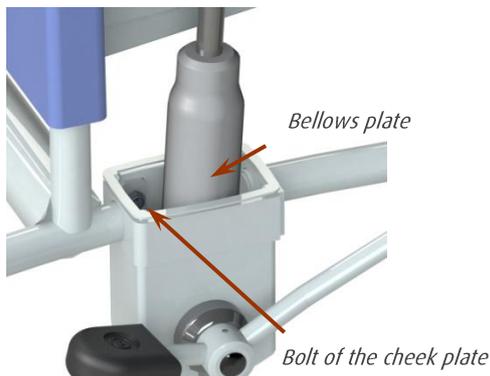
Figure 3 Bolt of the cheek plate

3. Detach the bellows at the bottom of the bellows plate pull them over the pump.

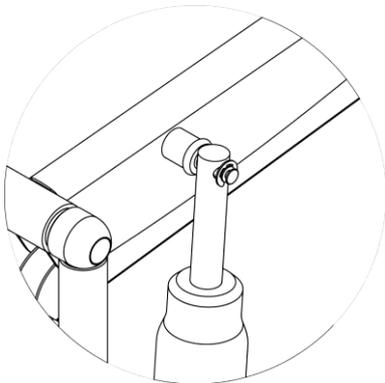
Figure 4 Pump mounting

1. Detach the bellows and slide them around the pump shaft. Remove the retaining ring.

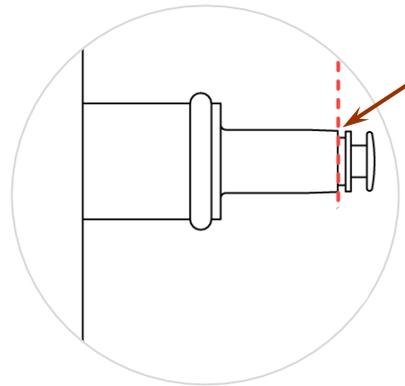
Figure 5 Hinge pin

2. Saw off the hinge pin.

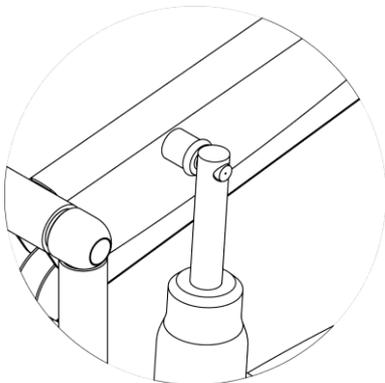
Figure 6 Hinge pin sawed

3. Mark the centre of the shaft.

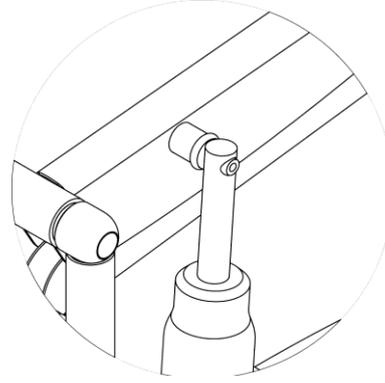
Figure 7 Hinge pin Screw thread

4. Drill a 5mm hole, at least 20mm deep, and insert tap M6 into the hole. Put the chair on its side so you can drill the hole.

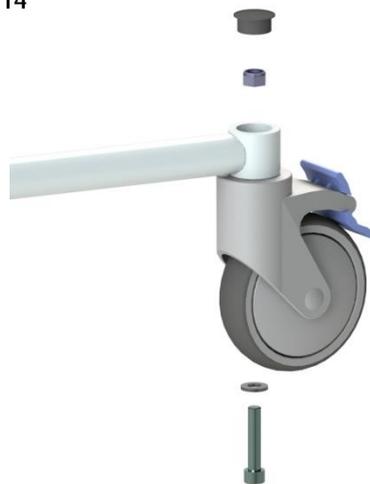
Figure 11 Wheel exploded view

- Check the attachment of the wheel (Tolerance)
- Check freewheel function + brakes.
- Do all four the wheels touch the floor on a flat surface? If not, check the chair right course.
- Brake lip intact?
- Check the tread.

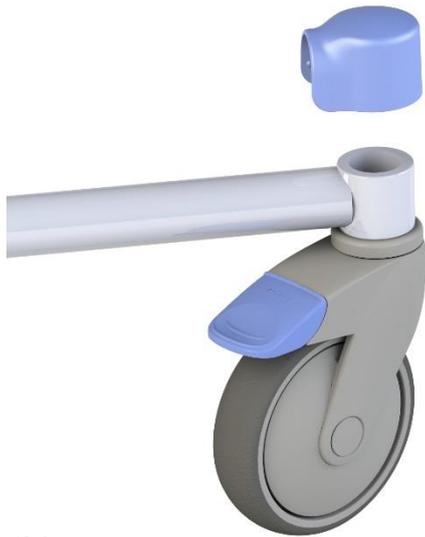
Figure 12 Cover

Chairs that are made before July 2014 are equipped with steel wheel clots. For those clots we have a cover to protect against damage.

- Remove the decorative plug
- Is there corrosion on the wheel clots?
- Remove loose corrosion with a wirebrush.
- Treat the wheel clots with rust converter Noverox.
- Paint the wheel clots.
- Let the paint dry.
- Place the cover over the wheel clots.

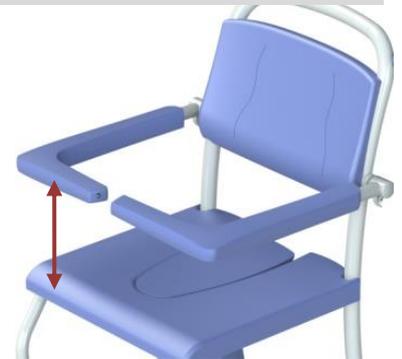
Figure 13 Armrest

- Inspect its functioning, and check for any damage, corrosion.
- Check its room for motion, measured at the front point (replace if it is more than 4 cm.) (See figure 13).
- Always treat corrosion.
- Are the arm supports evenly positioned?
- Slide PUR back if necessary.
- **The stainless-steel (A2) screws and M8x16 DIN912 quality 12.9. should always be replaced by a Super Duplex 4529 screw M8x16 (Order this bolt by Lopital B.V. Art.no. 75005640).**
- Fastly secure screw. (See figure 14)

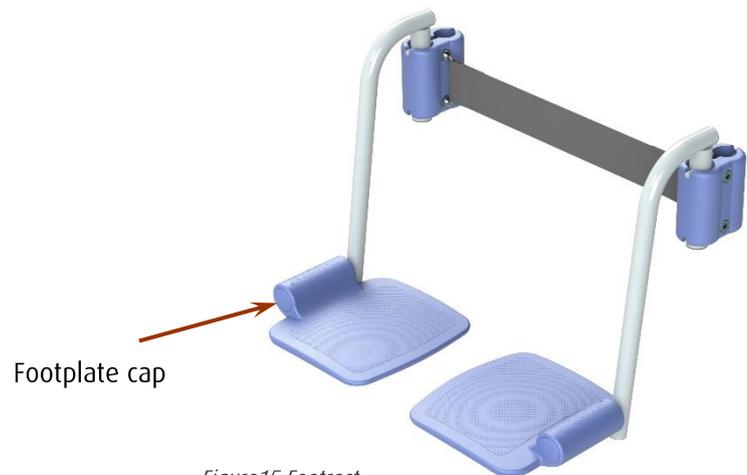
Figure15 Footrest

- Check for any damage.
- Fold up foot plates (should be stiff and stay upright). (They should remain in the folded position, without falling back automatically)
- Are the foot plates evenly fitted and slanting upwards a little towards the middle?
- Check whether the footrest clamps are still properly secured
- Is the footplate cap present?

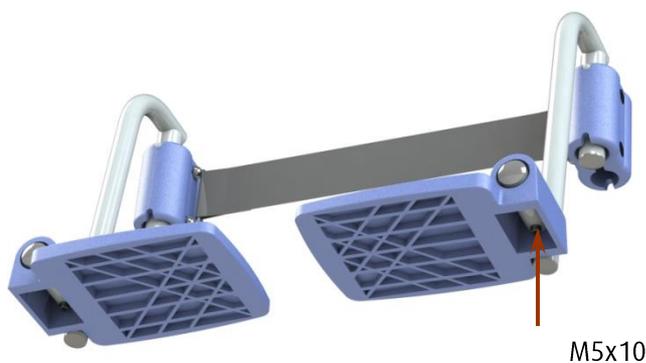
Figure 15 Footrest

- Check for any damage.
- Fold up foot plates (should be stiff and stay upright). (They should remain in the folded position, without falling back automatically)
- Are the foot plates evenly fitted and slanting upwards a little towards the middle?
- Check M5x10 (bottom of plate), and replace stainless-steel screws with ELVZ 8.8 screws. (See figure 15)
- Check if the footrest clamps are tight

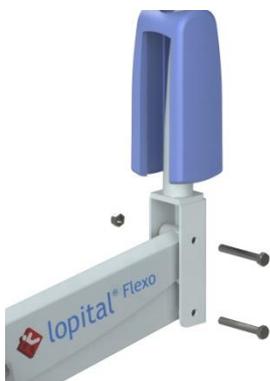
Figure 16 Disassemble chair frame

1. Lift the PUR hinge cover and detach the nuts. Remove the bolts and remove the chair frame from the undercarriage.

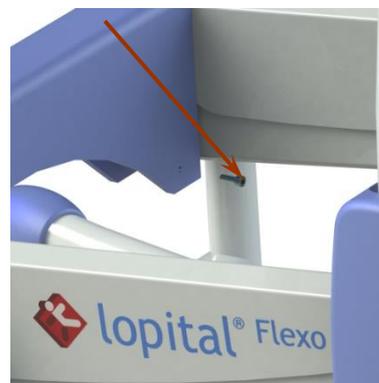
Figure 17 Disassemble frontcap

2. Remove the front cover by detaching the bolts at the back of the cover.

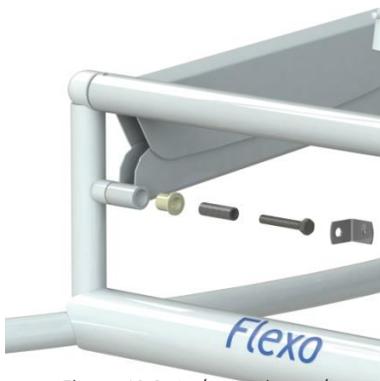
Figure 18 Detach steering rod

3. Detach the steering rod.

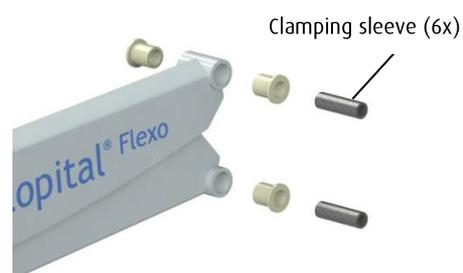
Figure 19 clamping sleeve and bearings

4. Remove the clamping sleeve and bearings (they are usually very tight, because of plaster or rust).

5. Fit the new plastic sleeve bearings and the new clamping sleeves. Put the steering rod back (seal bolt with Loctite strong). Refit the chair frame and fit the bolts and lock nuts.
