Sled Impact Test

**HG 1301**

**Frontal Impact of a Hoggi SWINGBO-VTi Manual Wheelchair  
Secured by a Surrogate Four-Point, Strap-Type Tiedown  
and Loaded with a Hybrid III Small Female ATD Weighted to 130 lb  
Restrained by a Surrogate Three-Point Belt with Wheelchair-Anchored Lap Belt**

Tested in accordance with Annex A of  
RESNA WC-4:2012: Section 19, *Wheelchairs Used as Seats in Motor Vehicles*  
and ISO 7176-19 (2008): *Wheeled Mobility Devices for Use in Motor Vehicles*

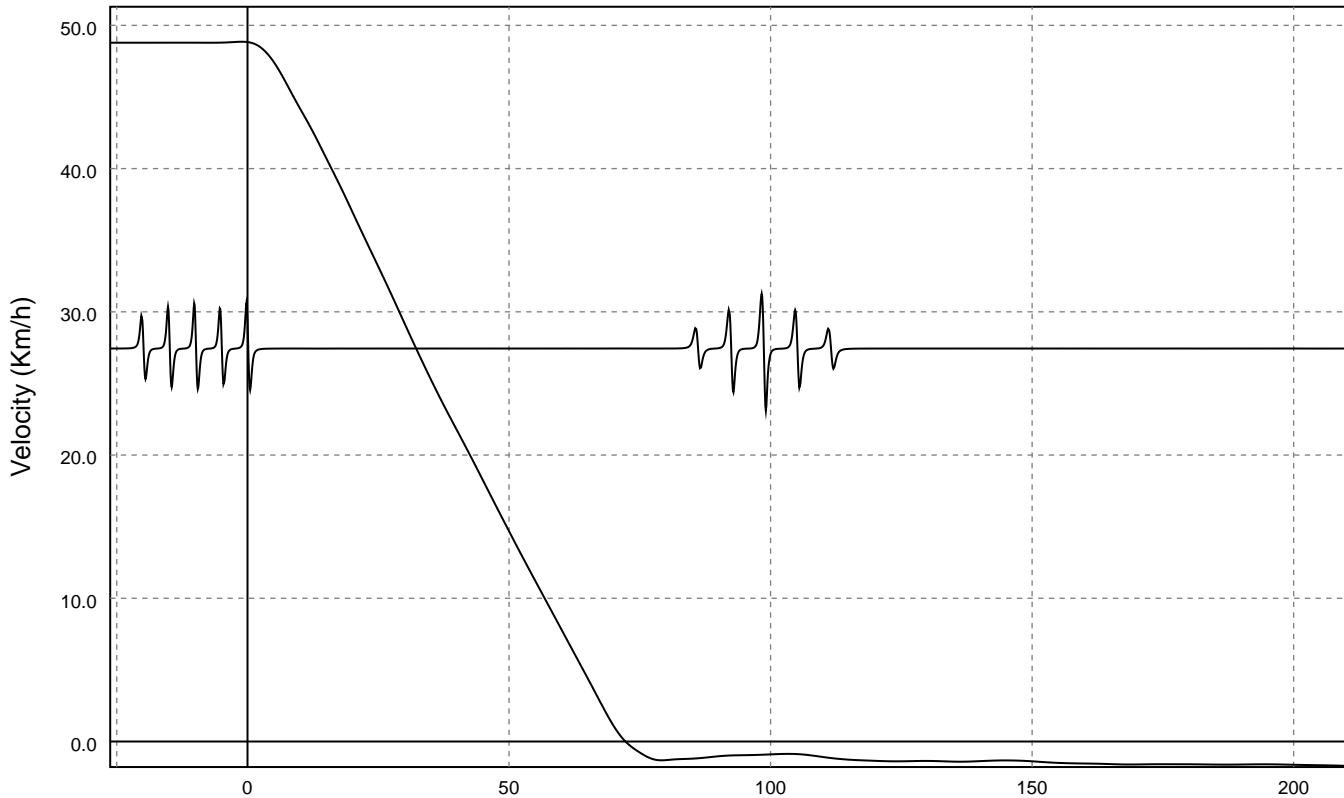
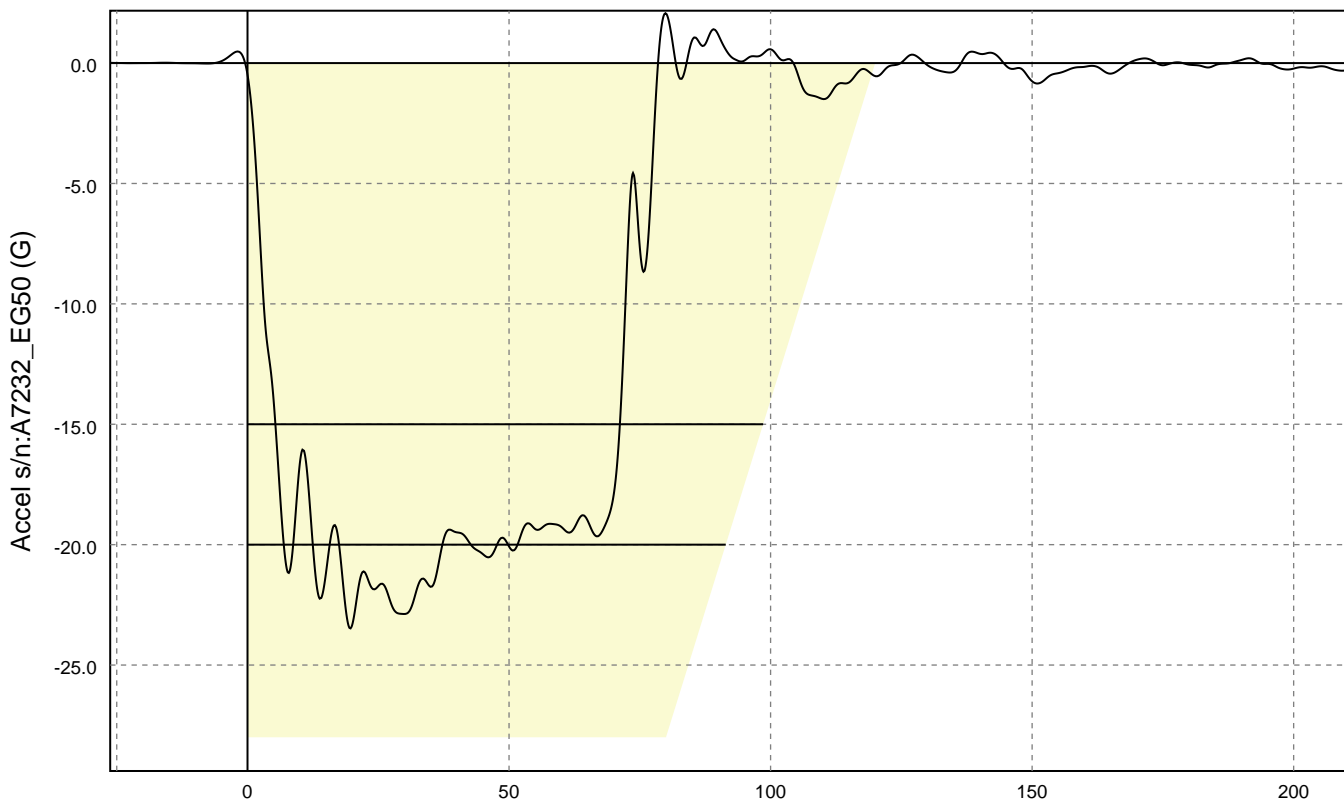
## **TEST SIGNALS**

Continuous time under -15.0 G was 65.8 ms  
Total time under -20.0 G was 31.7 ms  
Sled Decel Peak = -23.5 G  
Sled Plateau Average Level = -20.4 G  
Sled Pulse Duration = 79.0 ms

Stopping Dist. (est) = 0.565 m  
Sled Delta V = 49.0 kph (30.5 mph)  
Efficiency =  $V_{out} / V_{in} = 21.60 / 27.44 = 78.7\%$

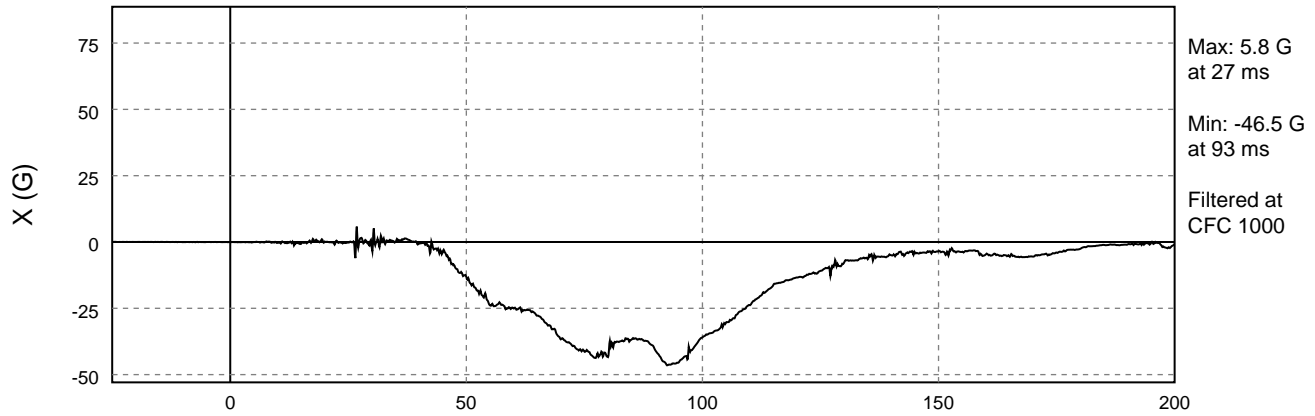
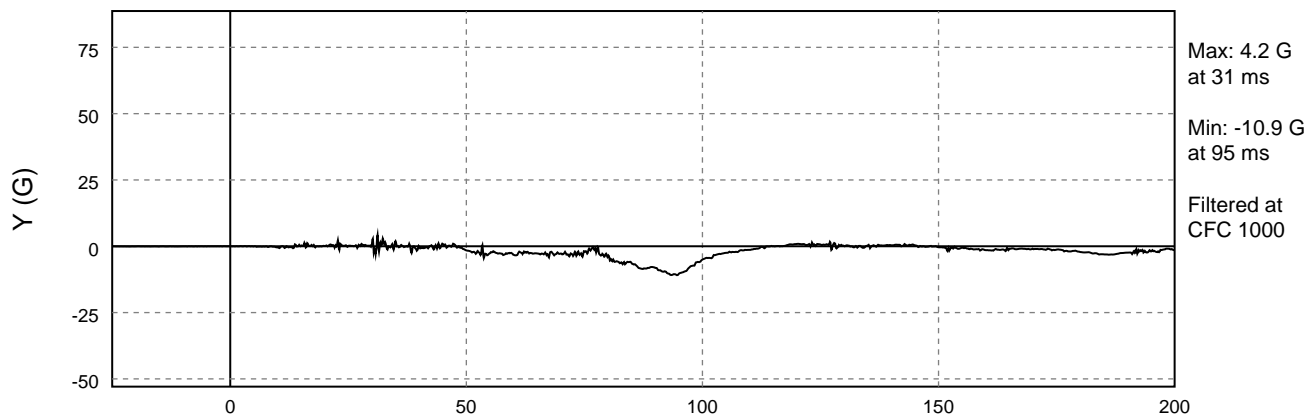
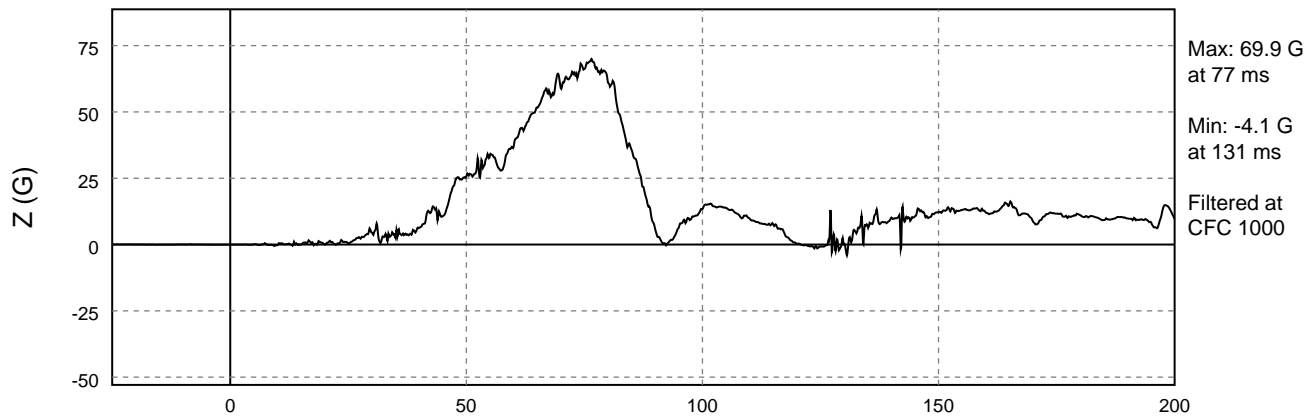
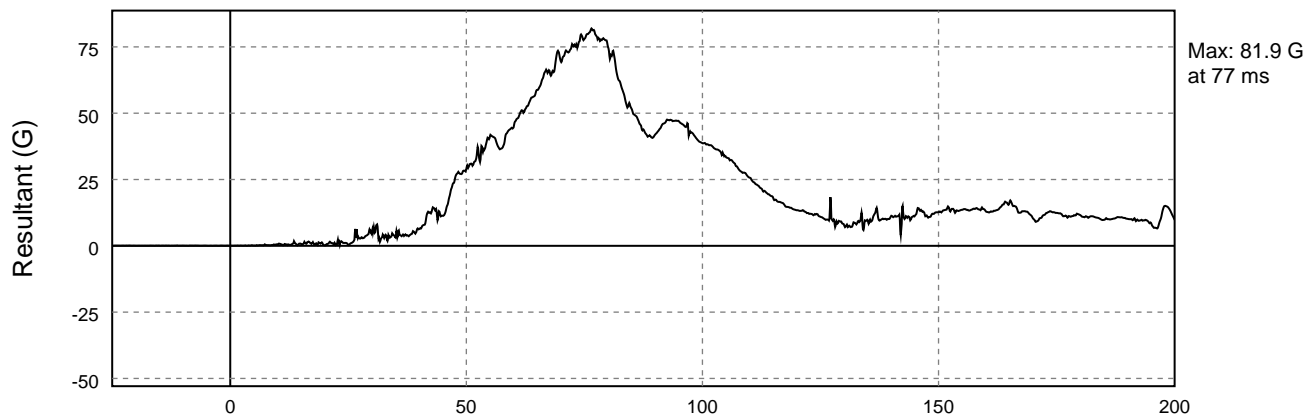
H.I.C. (15) = 714.3  
H.I.C. (UN) = 1108.9

From: 66.8 to 81.8 ms  
From: 51.7 to 106.5 ms

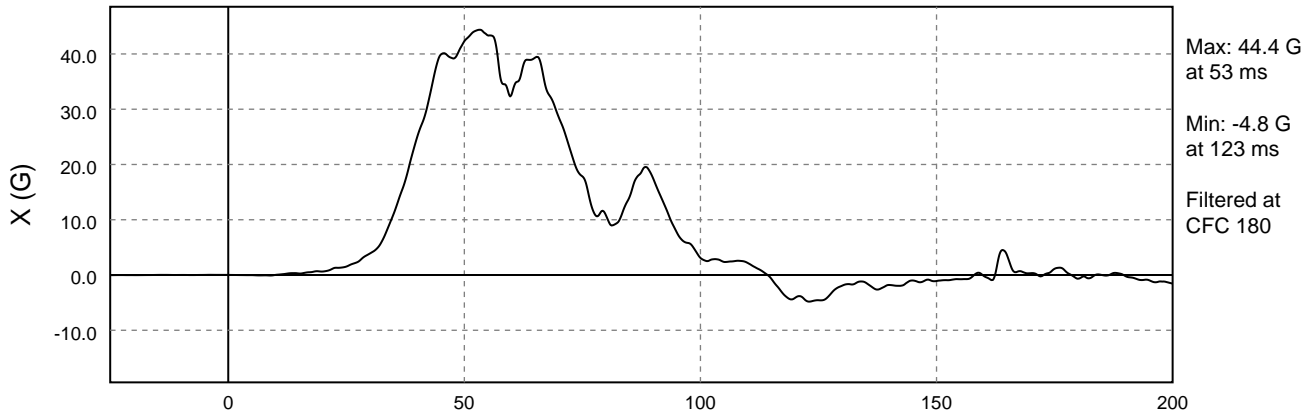
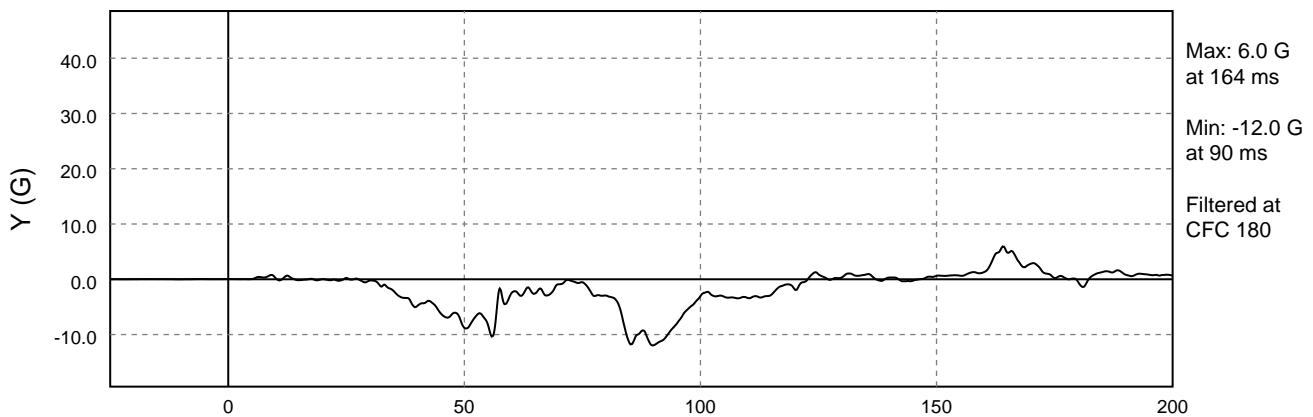
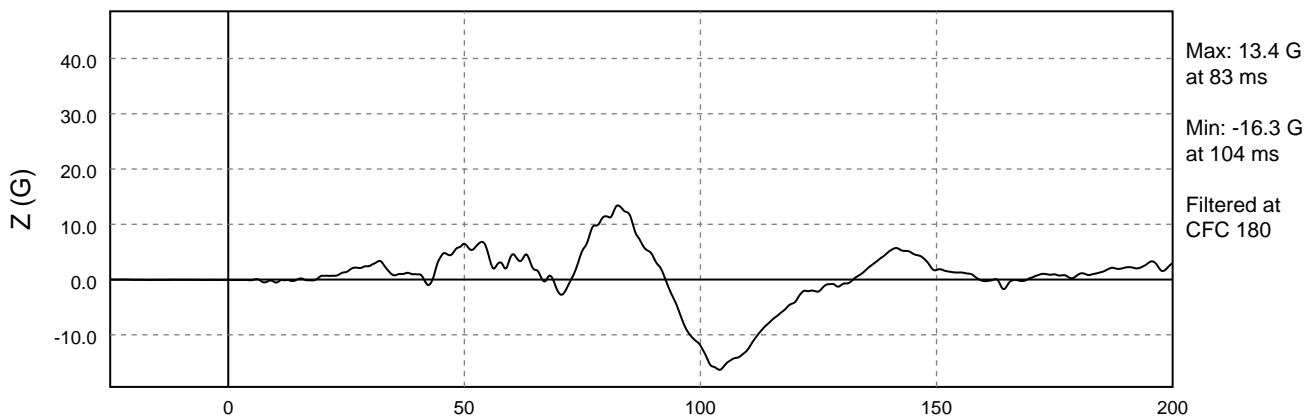
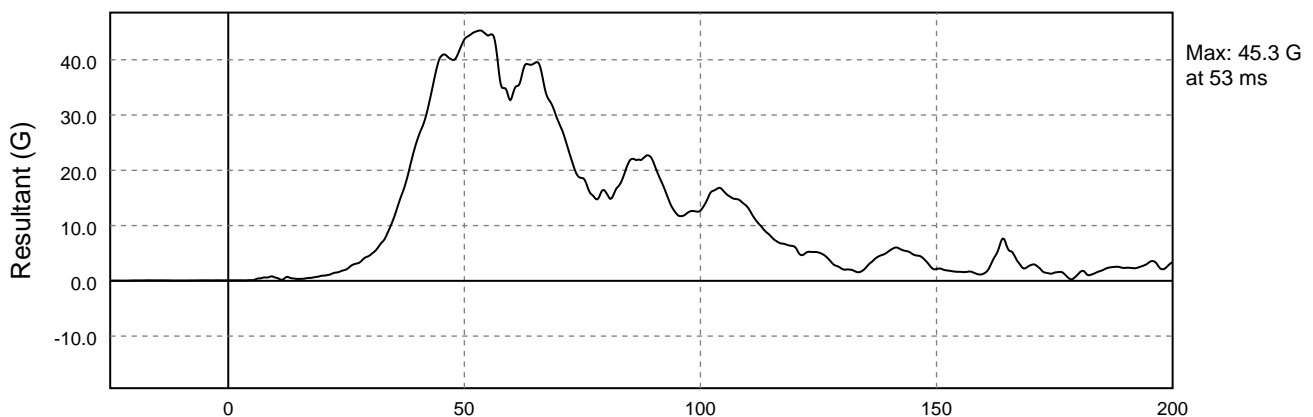
Total time over 60.0 G was 0.0 ms  
3.0 ms Clipped Peak = 44.7G

From: 51.5 to 54.5 ms
