## TESTING REPORT

**Commode chair - ISO classification 09.33.03**

**07.18A**

Product tested: **XXL Commode Chair**

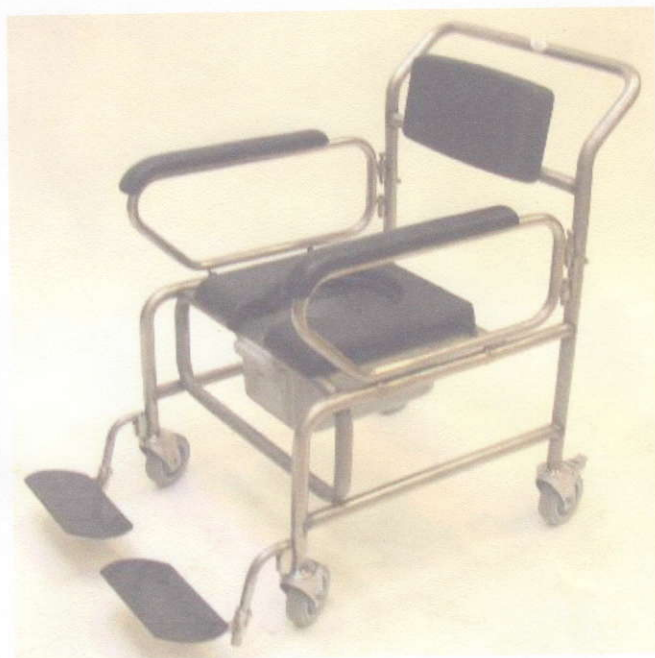
The product tested is a commode chair for very large persons. As may be seen from the photography below has the product tested a slightly prototype like character.

The product was without any marking, and there were no instructions for use delivered.
