Certificate of Crash Test according to

ISO 10542-1:2012 Wheelchair tiedown and occupant-restraint systems - SWM
&
ISO 7176-19 – 2022 Wheeled mobility devices for use as seats in motor vehicles

Project: Medema MC1144 w. Dahl Docking

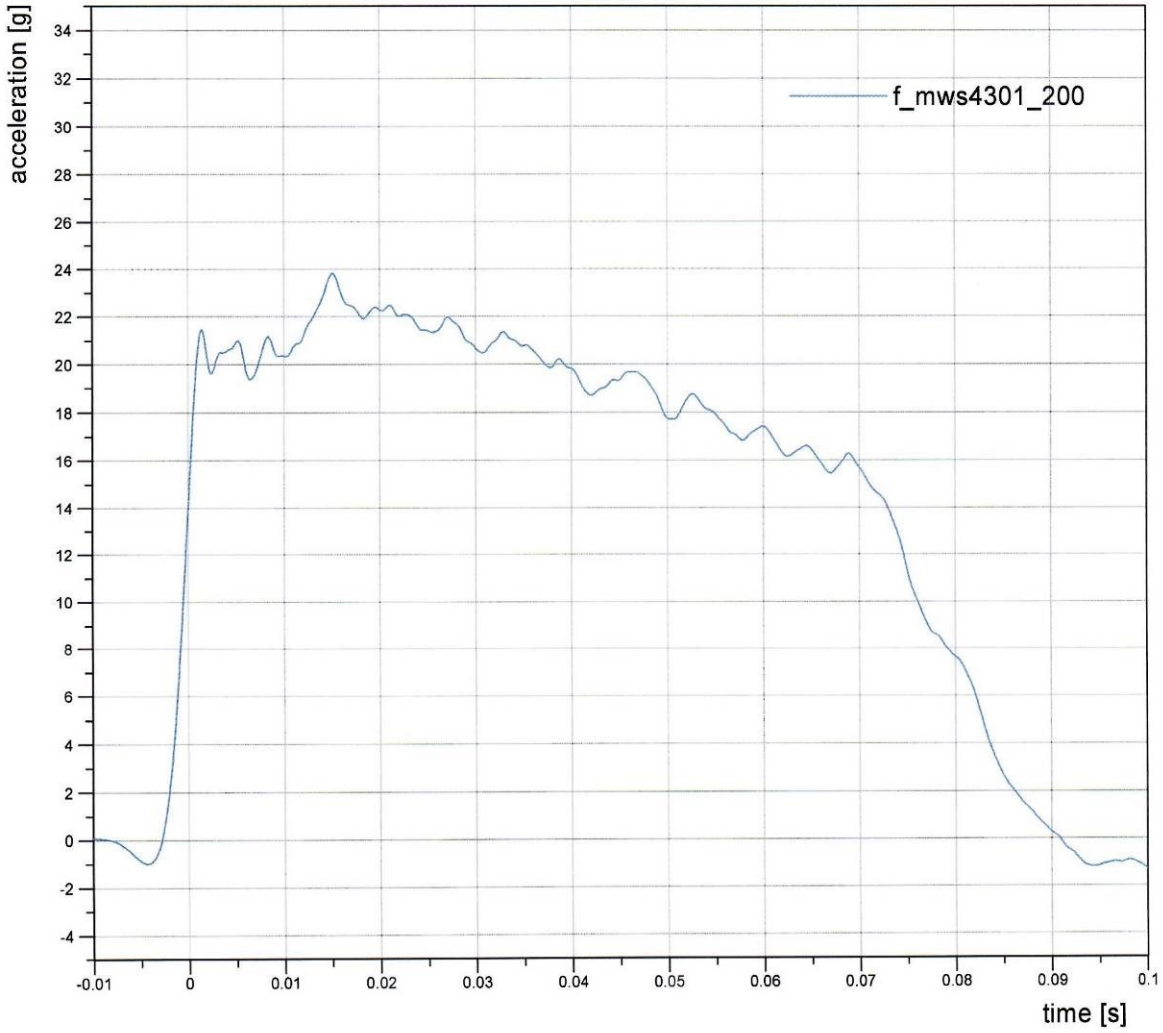
Plotted graph and speed

Editor: CDP	Specification: ISO10542 SWM / ISO7176-19
Date: 05/23/2022	Test type: Homolgation Test
File: Medema2022-015	Test structure: Sled
Sensors: MWS 4301, S/N-Nr.:SA-0263	Test sample: Medema MC 1144 Spinalus 3
Measurement: A/D Karte, DT 321	Comment to sample: With Dahl Docking
Analysis Sequence: Standard	Occupant: HybridII 50% Male
Sled velocity: 48.9 km/h	General comment:

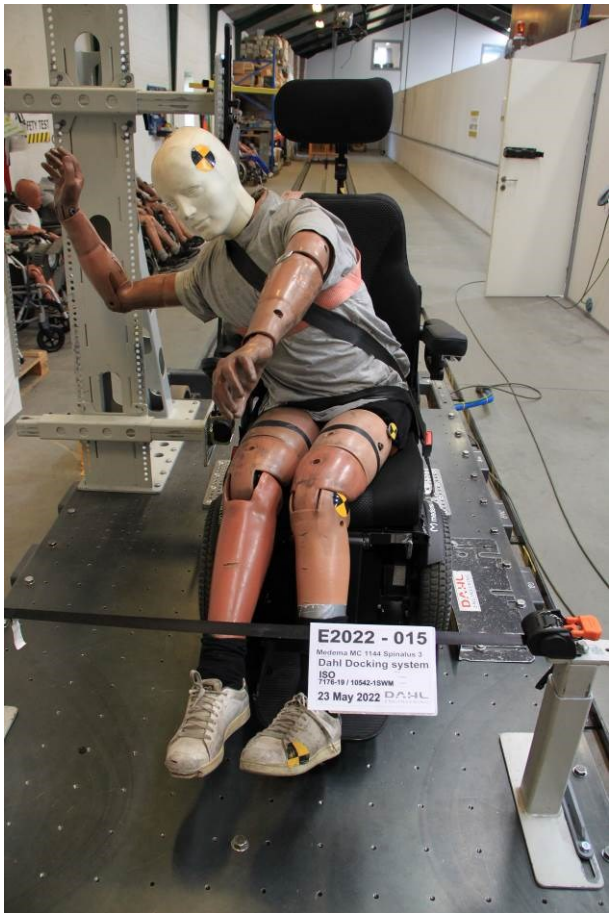
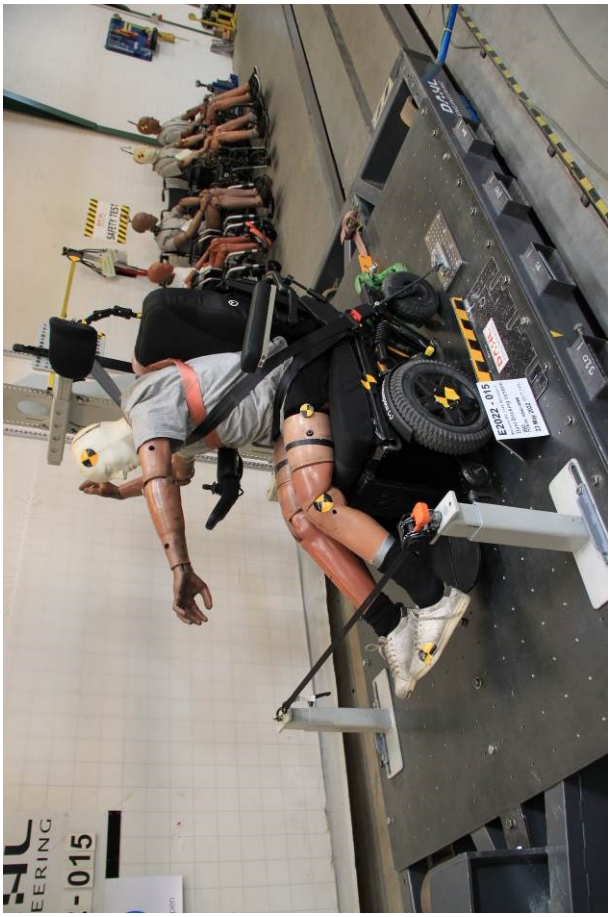
Post test photos

5.2.2	**After the test**	
	The wheelchair remained in an upright position on the platform	X
	The ADT remained in the wheelchair with its torso at an angle of not more than 45º to the vertical, when viewed from any direction	X
	There were no visible signs of material failure on the wheelchair securing points	X
	There were no components, fragments or accessories of the wheelchair with a mass of more than 100g that completely separated from the wheelchair	X
	There were no fragmented or separated component, that may contact the occupant, produced with sharp edges less than radius 2 mm	X
	There were no visible signs of failure on the wheelchairs primary load carrying components	X
	There were no visible signs of failure on the wheelchairs seat adjusters	X
	The ADT was removed from the wheelchair without the use of tools	X
	The wheelchair was released from the tie-down system without the use of tools	X
	The post test decrease of the mean H-point height is not more than 20%	X
